## **Remote Office Internet Goes Down Frequently After Modem Replacement**

*Zerowait Corporation  
707 Kirkwood Hwy  
Wilmington DE 19805*

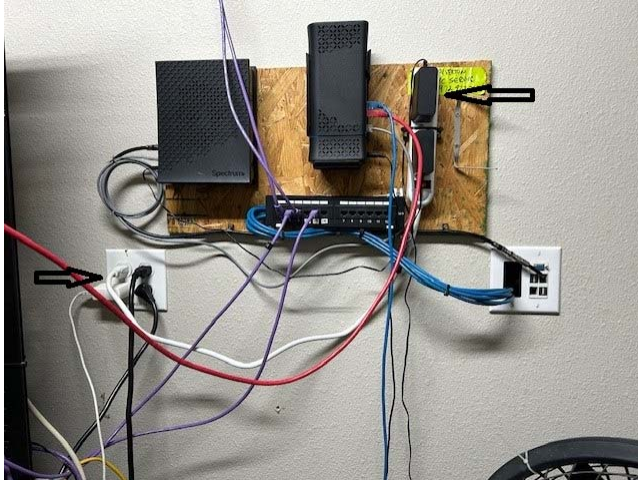
We have two UPS units in the server room. The one in the system cabinet powers the power distribution strips along the side of the cabinet. These accept special NEMA 13 type power cords. The Spectrum modem and its partner unit have regular computer cords with NEMA 15 110v ends. We have other devices with NEMA 15 cords, and thus had an additional UPS (Cyberpower CP550SLG) on the floor to support them.

plugged into the UPS, we immediately discovered that the UPS batteries had failed and the "Surge/Battery" side of the UPS had no working outlets. The "Surge" side was working. Our Room Alert device was plugged into the "Surge" side. There were no other important devices on the UPS.

We have been experiencing frequent power fluctuations at this location in Texas, as documented by our Room Alert system. With this new UPS discovery, we now believe it is possible that our frequent internet service interruptions from the Spectrum circuit had been caused in part by the lack of a properly functioning UPS to keep the modem up long enough for generator power to take over.

- **Replace Failed UPS:** We had a spare CyberPower CP1500AVRLCD3 that we had recently replaced the batteries in.
- **Connect power to the Modem power Strip:** Using the repaired UPS, we reconnected the modem to power and tested the internet connection. We also ensured that all systems in the rack were operational and working optimally.
- **Cleaned up the Server room:** The remote office's server room had quite a few redundant and unused Cat-5 cables and power cords, cluttering the area. These were removed.
