When the Unexpected Occurs It's How You Respond that Matters

Shipping Mishap

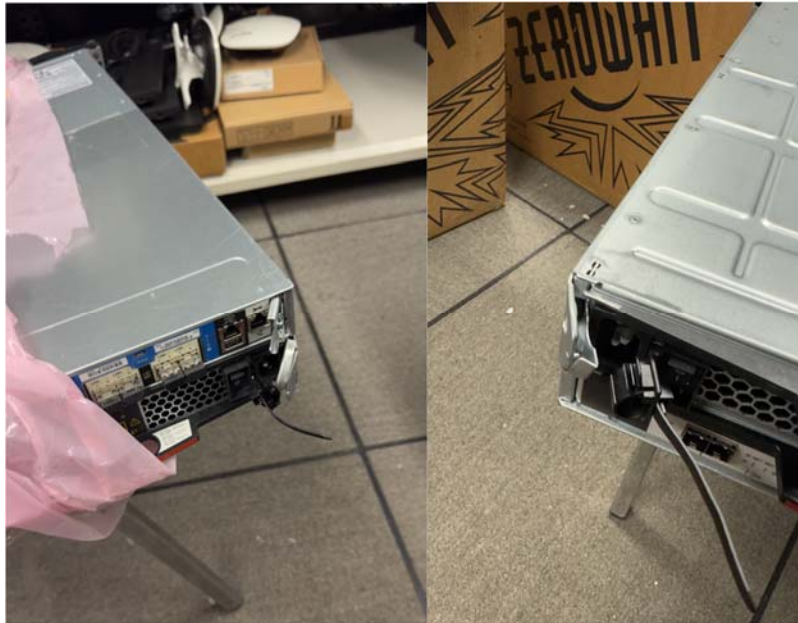
Situation: The customer received their transferable, licensed NetApp filer. Dual controllers and multiple disk shelves. Upon opening the boxes, they found that the chassis of one controller and of one shelf had bent rear tabs. Zerowait had to act quickly so as to not delay the customer installation and migration of data. Of particular concern was the controller module. If it was inoperable, it would be very difficult to repair or replace as its licenses are tied to its serial number.

- **Physical Inspection:** Except for the bent tabs, the chassis appeared undamaged. Using tools at hand, we bent them back into alignment. Power supplies and the controller modules were able to slide in and out without issue.
- **Power on and Diagnostics:** We powered on the system and shelf and ran complete diagnostics on all components. There were no issues. The system, shelf, and drives worked perfectly. The controller modules, which were of primary concern, were fine. Although we had ways of dealing with this, thankfully we didn't have to.
- **Decision Tree:** While we could have sent back the repaired hardware, as it now had only light cosmetic flaws, we opted instead to swap out the chasses and power supplies from our stock. We did this and ran the diagnostics again. We also burned the system in overnight as an extra precaution. All went well.
